Control Gate-Bit Line Leakage induced Cobalt Silicide Migration in 0.15um Embedded Flash Memory Devices

Sang Hyun Han, Dong Ju Son, Nam Sung Kim, Young Seon You, and Robert Kuan

Systems on Silicon Manufacturing Company Pte. Ltd.

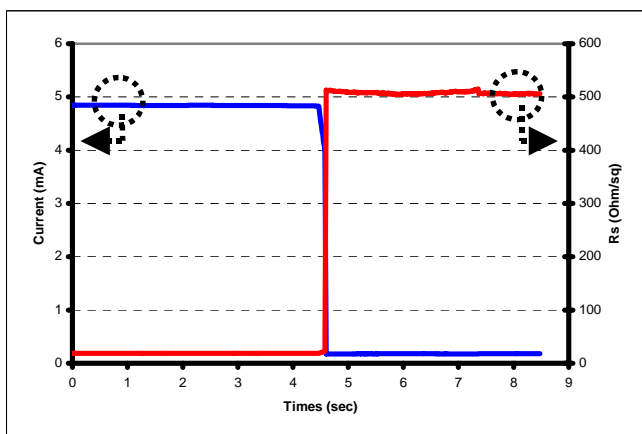
In order to simulate missing Co silicide phenomenon using high voltage stress, we selected Co silicided poly resistor, applying high voltage (15V) to the Co silicided poly resistor via contact. During the electrical stress, current suddenly dropped and sheet resistance jumped up to 500ohm/sq from 10ohm/sq at around 4.6sec stressing (Fig. 1). From Failure Analysis (Fig. 2), it was found that not only was the missing Co silicide discovered near the contact plug and unusually thick polysilicon of 2750Å as compared to normal silicided poly resistor (1750Å) was also discovered there. Before the Co-silicide reaction, the deposited poly silicon thickness was 2000Å. After further experiments, it was confirmed that electrical stress causes Co silicide migration and there is also a critical stress density to trigger this migration.

Fig. 1. Current and Sheet resistance with constant voltage stress (15V) as a function of time at Co silicided poly resistor

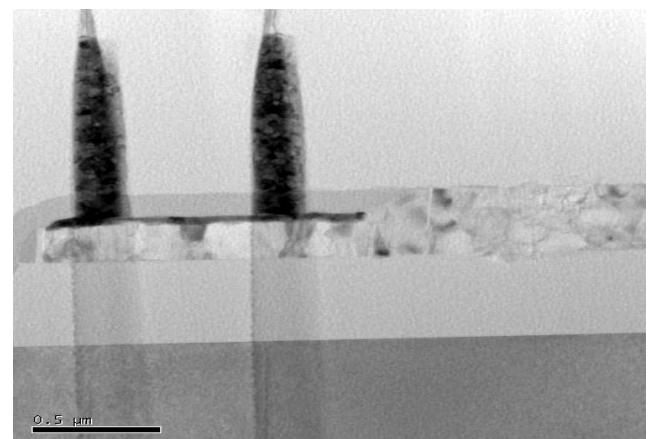
Fig. 2. Missing Co silicide area on poly resistor after electrical stress
